**UNITED STATES AIR FORCE
ARMSTRONG LABORATORY**

**463L PALLET AND DUNNAGE SYSTEM
EVALUATION**

October 1997

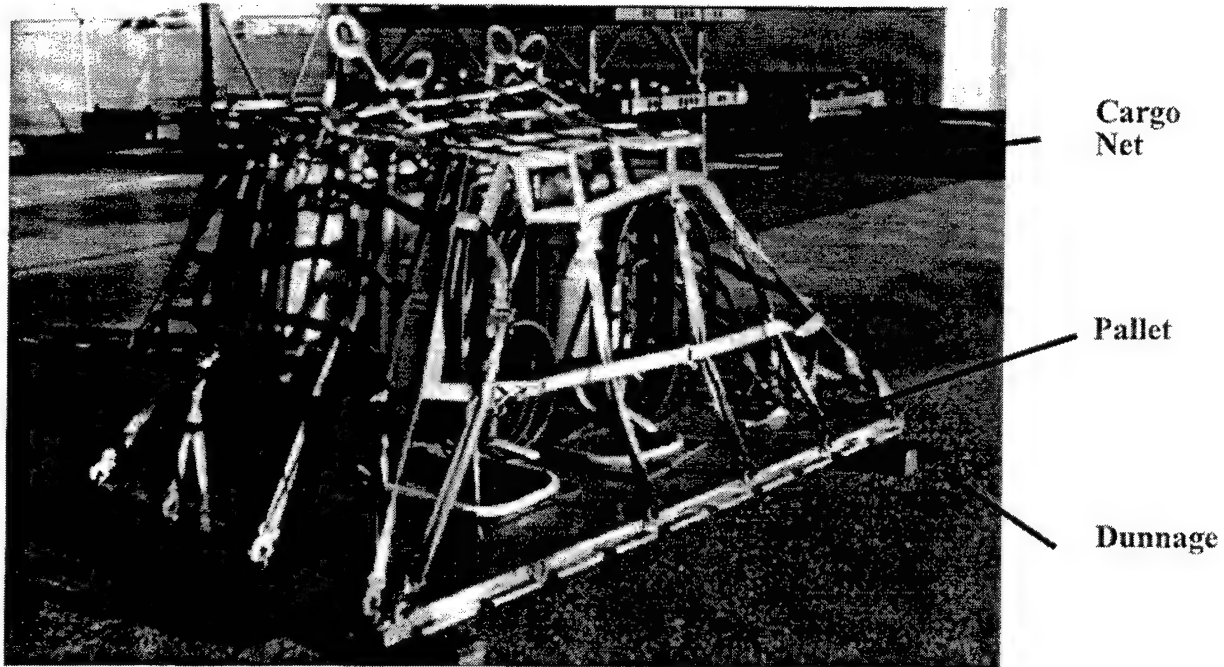
The 463L Pallet System consists primarily of the 463L pallet, dunnage, cargo netting, plastic cover, forklift, k-loader, aircraft rail system, and manpower. A combination of these components make up the entire system. Although, the concentration is on the pallet and dunnage, an understanding of all functional parts of the system and how they interact is important.

Figure 1: Loaded 463L Pallet

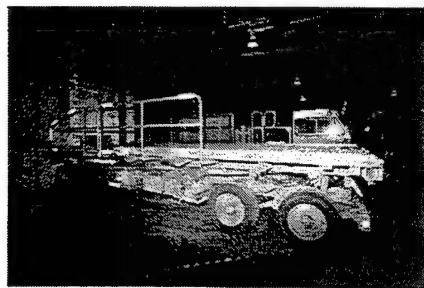
The K-loader is used to transport several pallets from the loading area to the aircraft. It contains a similar roller system to that of the aircraft's. The loader has the ability to carry the loaded pallets and lift them to the height required to push them into the aircraft.

Figure 3: K-Loader

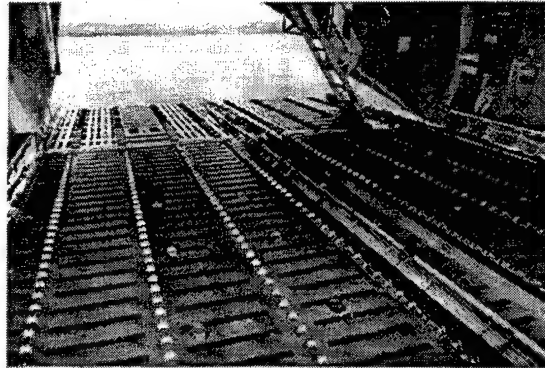
The aircraft rail system was specifically designed for the 463L pallet. The system contains rollers to ease the loading and removal of loaded pallets. Also, it contains a locking system to secure the loaded pallets during flight. The same rails are used on the k-loader.

Figure 4: Aircraft Rail System

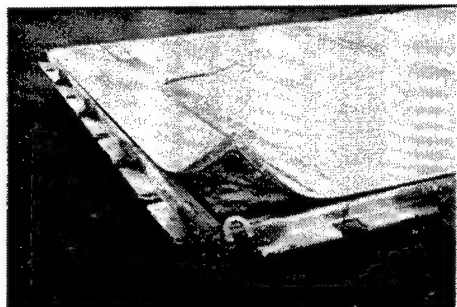
Personnel must be trained to detect the various types of pallet damage. Before building cargo up on the pallet, the pallet top and bottom should be checked for serviceability. The most common types of damage to the pallet are skin separation, skin punctures, warping, and missing or damaged D-rings. Any time damage is found, the pallet cannot be used to ship cargo. Instead, it is tagged and moved to the damaged-pallet staging area. Whenever the aerial port accumulates at least 10 damaged pallets, they will ship the pallets back to their regional hub (Travis AFB, Dover AFB, etc.). When the hubs accumulate approximately 120 damaged pallets, they will ship them back to the manufacturer for repair.

Figure 11: Pallet Skin Separation

Improper storage facilities, coupled with the pallet materials, account for a majority of pallet problems. The thin aluminum skin is glued to the side frames to keep the internal materials dry and give strength to the pallet. The glue bonding often separates under the normal stress of use. This separation allows water to seep into the balsa wood core, which expands with great force when wet. This expansion causes the skin to separate from the pallet frame (see Figures 13 and 14). Besides allowing water to seep in, outdoor storage near an ocean allows the salt air to corrode the pallet surfaces. Additionally, if nets are subjected to moisture, they must be thoroughly dried to prevent them from rotting.

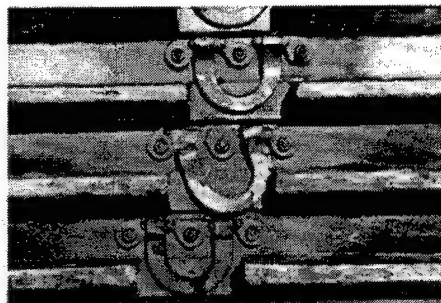
Figure 10: Damaged D-rings

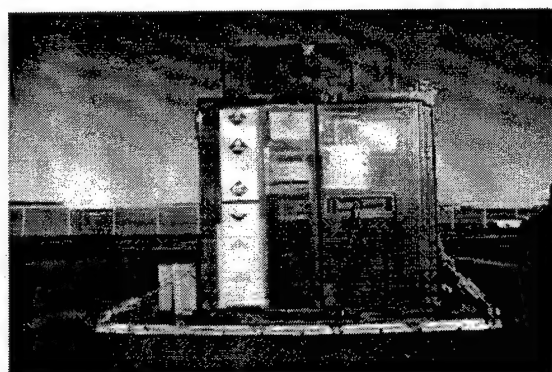
Loads that sit on a concentrated part of the pallet (especially when heavy) are tied down with chains and straps to prevent movement. This action pulls up on the side of the pallets and may permanently warp them. To a lesser extent, nets put consistent upward pull on all pallet rings. The upward pull on the pallet with cargo pushing down in the middle of the pallet can contribute to bowing. A warped pallet is likely to jam in the K-Loaders and in the aircraft rail systems. Jamming will cause loading delays and will often further damage the side flanges of the pallet.

Figure 12: Heavily Loaded Pallet

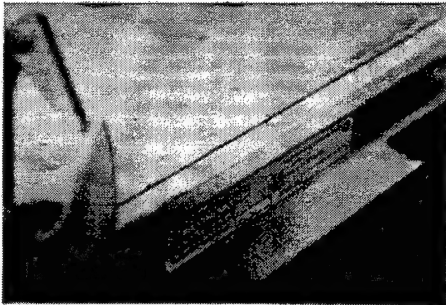
Figure 13: Brand New Pallet

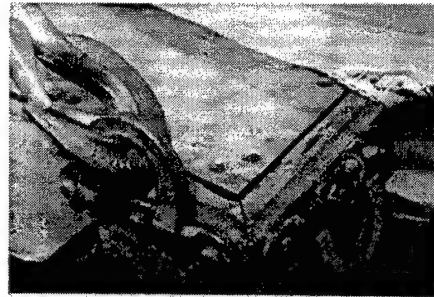
Figure 14: Pallet with Skin Separation

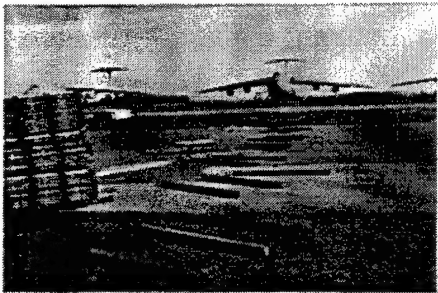
In the larger aerial ports, a large area will be semi-permanently set up for storage of transient pallets, referred to as the marshalling or staging area (Figure 15). These areas are often relatively flat blacktop lots where rows of dunnage (groups of 3 pieces appropriately spaced on the ground) are laid out on the ground. These pieces of dunnage are continually exposed to sun, rain, snow, heat, cold, etc., all of which deteriorates them. In addition, fork-lift trucks may run into the dunnage, splintering and breaking the wood (especially at night when the dunnage is hard to see.)

Figure 15: Marshalling Area

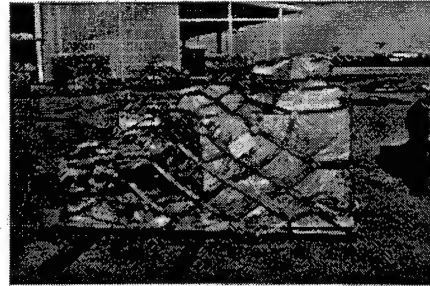
Figure 16: Wood Dunnage as Protective Flooring

Dunnage may also be used to distribute cargo weight, provide protective flooring, stabilize equipment, and build equipment ramps to aircraft. Wood used for these purposes is called "shoring". Dunnage is often diverted for shoring purposes and then not returned for dunnage use.

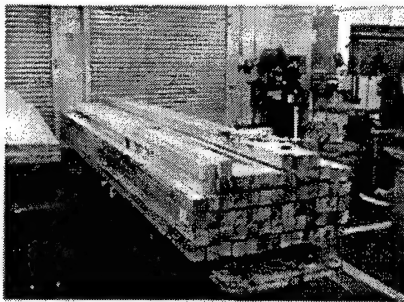
Wooden dunnage accomplishes these tasks, but requires that three similar pieces of wood be available whenever the pallet is set on anything other than rollers. This approach requires additional personnel and other resources to move, store, position, and attach the dunnage to a pallet. If less than three pieces of dunnage are used, or if any one of the pieces is different from the others, the pallet may warp due to uneven weight distribution. Dissimilar pieces of wood is a common problem at aerial ports, especially smaller ones. However, if personnel inspect for uniformity before using the dunnage, damage to the pallet can be prevented.

Figure 18: New Wooden Dunnage

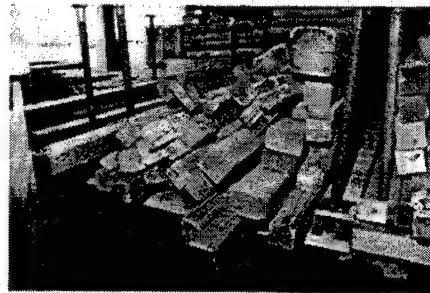
Figure 17: Used Wooden Dunnage

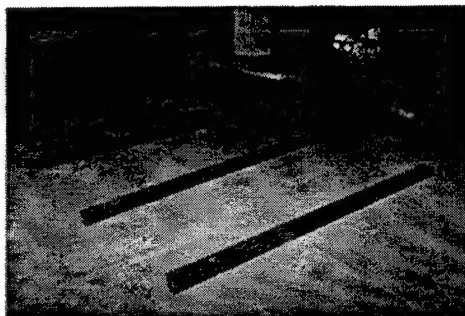
The ReNew pieces are made of a polyolefin-based plastic lumber called Perma-Poly™. A complete evaluation of Perma-Poly™ was carried out at Battelle Memorial Institute's

Industrial and Commercial Development Division, Polymer Product Center, in Columbus, Ohio. Appendix D contains the complete study plan, test procedures, and test results. The results are presented in a way that could be interpreted for application to other types of plastics suitable for dunnage. It should be noted that Black Rhino Recycling, Inc. currently has plastic lumber in various shapes and sizes available through government supply channels. Some aerial ports have already begun to use Black Rhino's 4"x4"s as dunnage.

Figure 19: ReNew Plastic Dunnage

The material property analysis found the plastic lumber to be essentially the same as or better than the wood in all cases except two: agent decontamination and density. After exposure to chemical warfare agents, decontamination may be more difficult for plastic than for wood. This scenario would be true if the contaminated dunnage needs to be disposed of. Wood is easily disposed of by burning. The polyolefin will also burn, but takes much longer. The plastic's higher density makes each piece significantly heavier than wood. A 4"x4"x88" piece of wood weighs around 15-20 lbs, compared to 25-30 lbs for the Perma-Poly™. However, Black Rhino also makes a hollow core dunnage which weighs only 13 lbs. Unfortunately, due to the limited scope of this task, the hollow piece was not analyzed for this study.

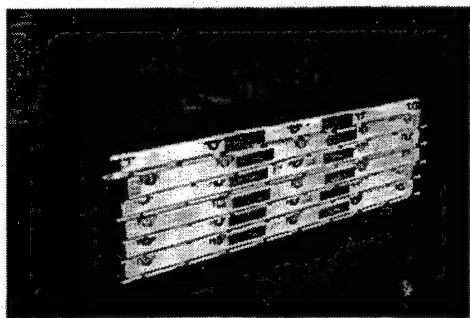
A modified design could also eliminate the need for dunnage, which is a labor and cost intensive resource. At the time the pallet was designed and deployed, there were more personnel resources available to handle dunnage. Today there are substantially fewer personnel resources available while the demand remains. One such design would be to build fork lift tines into the pallet. Figure 20 shows an example of this concept, the Air Cargo pallet, HCU-10/C. This modified pallet is manufactured by Cadillac and is 88"X54"X4-1/2". It has a maximum capacity of 5,000 lbs. This does not meet the requirements of the 463L, HCU-6/E, pallets, but the concept is functional.

Figure 20: HCU-10/C Air Cargo Pallet

Several issues arise with this recommendation. First, the bottom of the current 463L pallet is not durable enough to be placed directly on the ground. Therefore, punctures would occur and render the pallet unusable. Replacing the bottom skin with a harder material should eliminate this problem. Also, the forklift holes would raise the height of the pallet, thus limiting the height of the cargo that can be placed on it. Several aerial port personnel stated that such a height limitation would be unacceptable due to its adverse mission impact. Another concern is the addition of a time constraint to properly position the fork lift tines into the pallet slots.

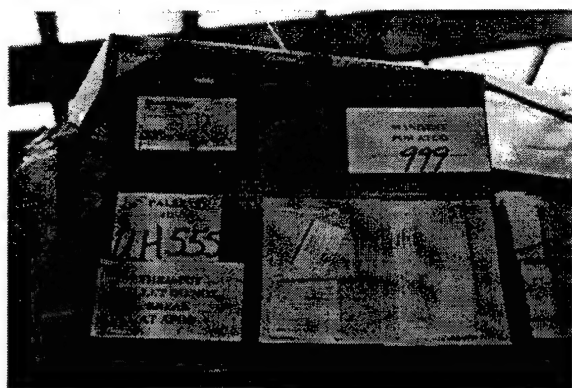
Figure 22: Identification Board with Laser Card

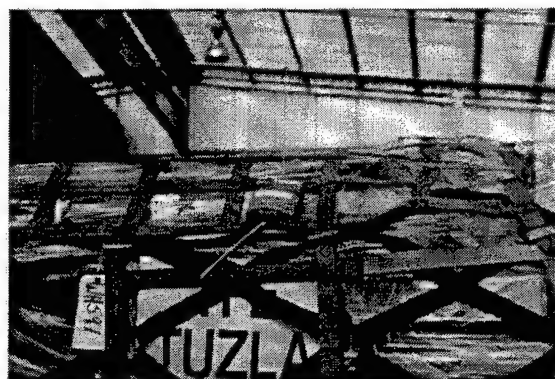
The US Army has a pilot program using SAVI technology that allows for the tracking of the pallet and its cargo. The Air Force is monitoring this program to determine its effectiveness. Other tracking methods currently used should be researched to determine their applicability to Air Force cargo transportation needs and the Total Asset Visibility concept.

Figure 21: SAVI RF Tag for Tracking

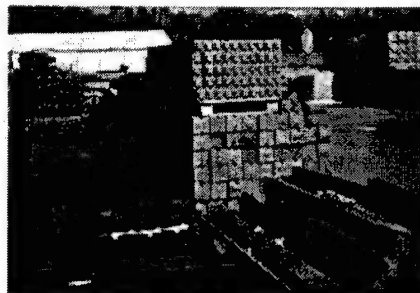
New designs, like Black Rhino's hollow pieces, should be researched to cut out some of the weight from the dunnage currently available in the Air Force supply system. Also, a non-slip surface will allow personnel to pick up the dunnage easier and keep pallets from sliding around. The plastic dunnage used at Ramstein AB, Germany was specifically designed for the pallet. The ends contain grips for ease of grabbing, and there are grooves along all sides to allow air flow, thus preventing the dunnage from freezing to the pallet.

Figure 24: Plastic Dunnage at Ramstein AB

Some valuable information was obtained at Ramstein AB, where the 623rd Air Mobility Support Squadron has been using plastic dunnage in their staging yard and pallet build-up areas since 1994. Since this initial purchase, not a single piece has been damaged to an unusable status. The following chart details how many plastic 4"x4"s Ramstein AB has purchased and the dollar amount saved from this purchase. It is assumed that the plastic will last 40 years (based on manufacturer's analyses), that wood only lasts 3 years (based on previous experience at Ramstein), and that the average cost for wood is half the price Ramstein paid for the plastic pieces. It should be noted that Ramstein bought bulk quantities of the plastic dunnage from a local manufacturer. Most plastic manufacturers in the United States quote higher prices, but many are willing to discount bulk orders.

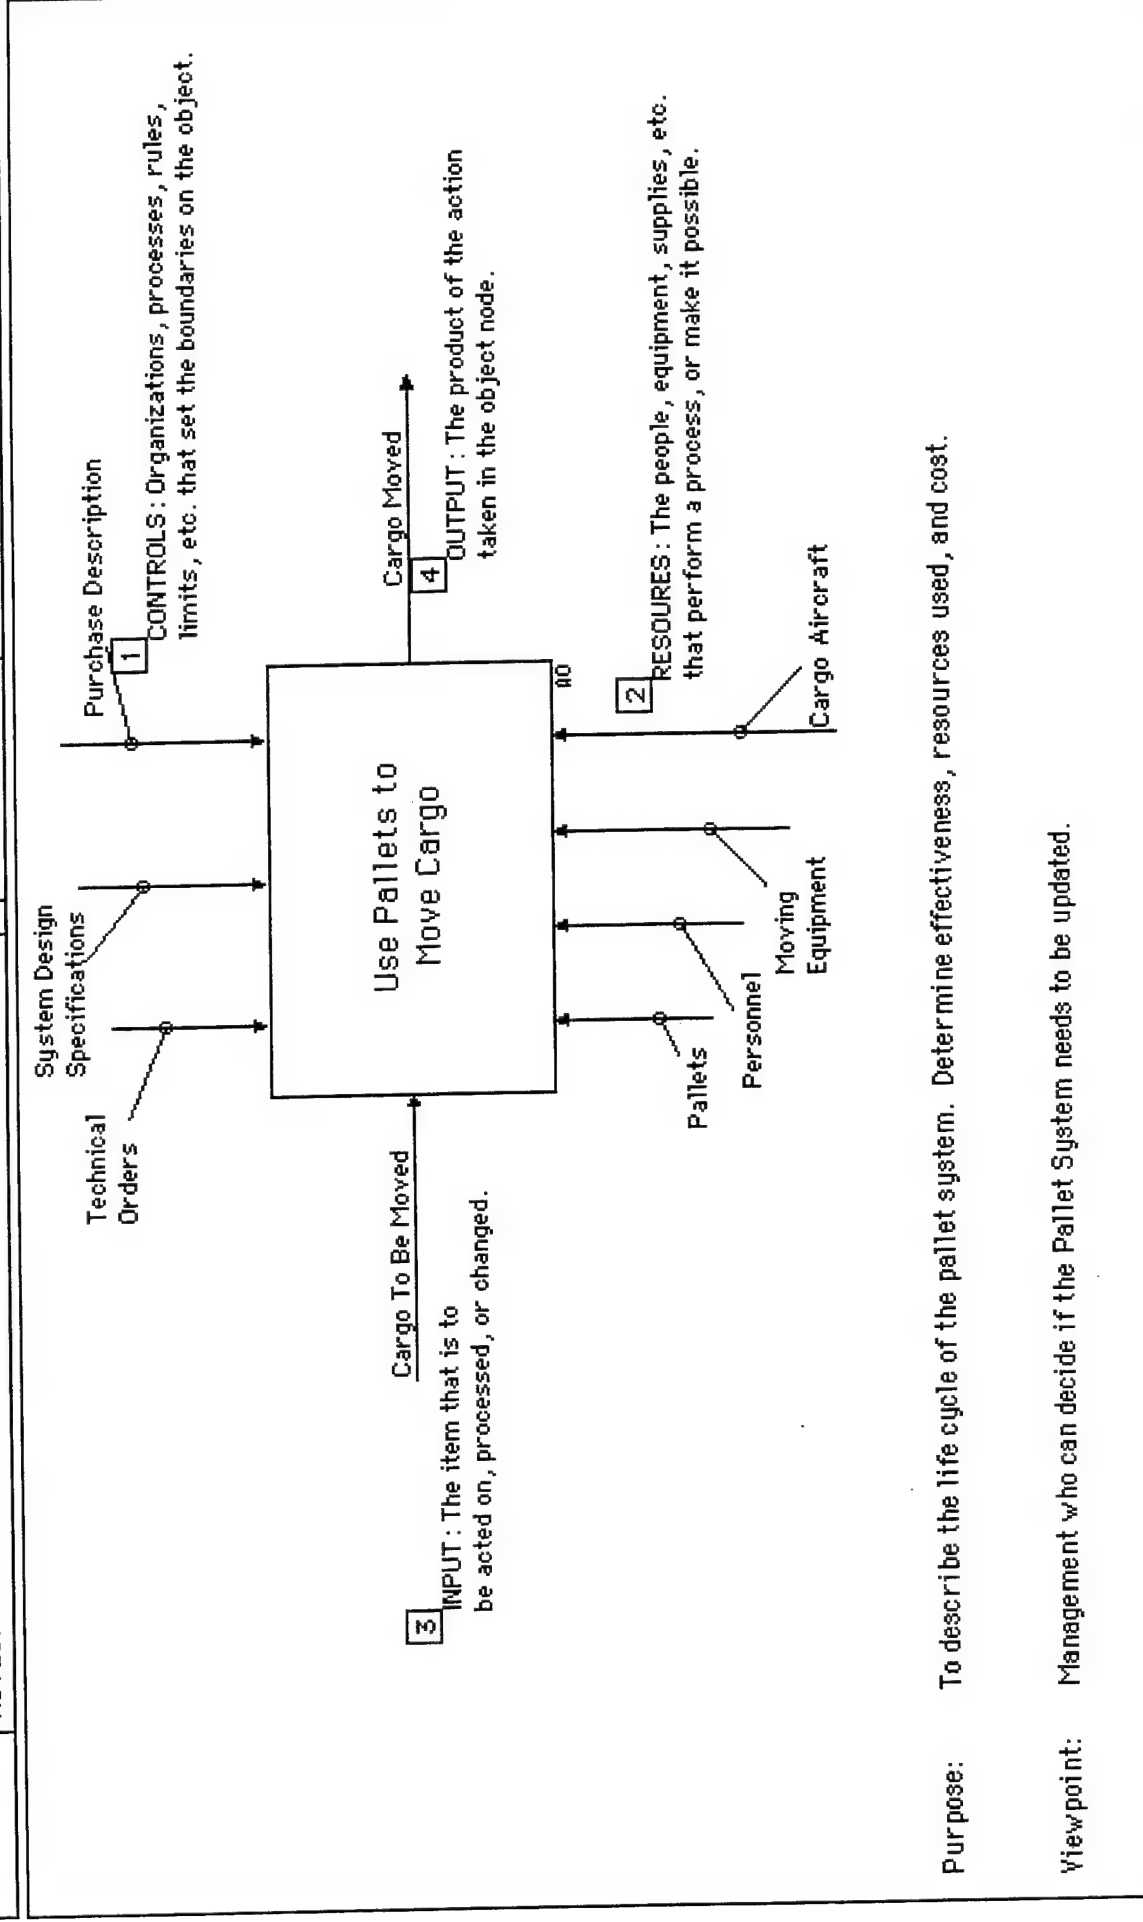
MODE: Pallet/A-0	TITLE: Use Pallets to Move Cargo	NUMBER:
------------------	----------------------------------	---------

Purpose: To describe the life cycle of the pallet system. Determine effectiveness, resources used, and cost.

Viewpoint: Management who can decide if the Pallet System needs to be updated.

At the start of this task a clear visualization of the life cycle of a 463L pallet did not exist. The following model was created to help identify all phases and functions that a pallet experiences. This model could be extended to provide more detail as needed. The model could also be the basis for a cargo system operation focused on pallet functions. Other documents reviewed for this project gave task performance times for many tasks associated with cargo movement via the 463L pallet. These times would also be directly usable via a simulation.
